MC68360

Errata and Added Information to

MC68360 Quad Integrated Communication Controller User's Manual Rev 1

January 8, 1998

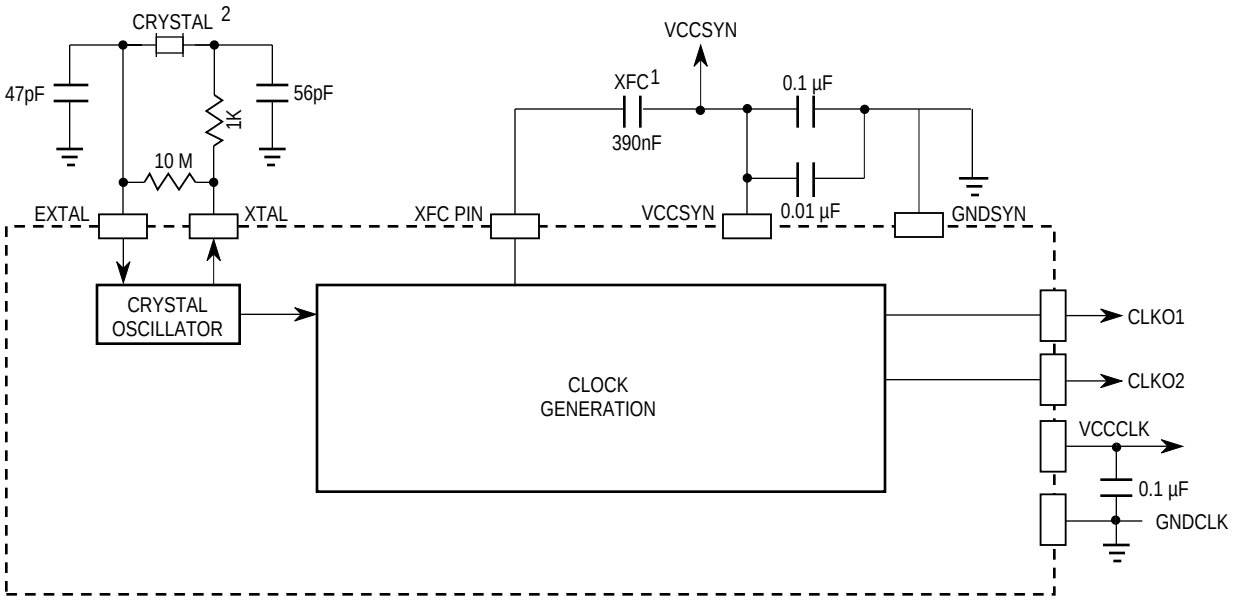
Figure 6-6A External Components for 4.192MHz

Also on page 6-14 the following figure should be added.

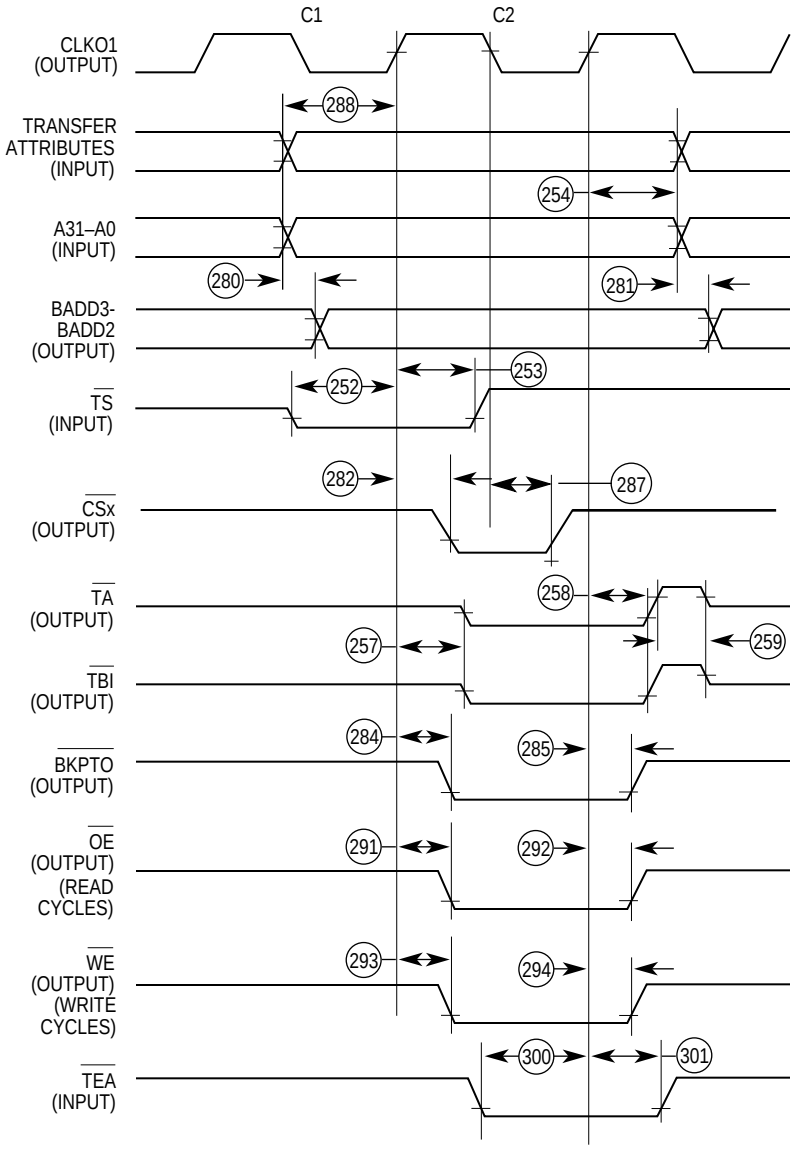
Figure 10-44(b) MC68040/EC040 SRAM Write cycle (TSS40=0, CSNT40=1)

The following figure should be added after figure 10-44(a)

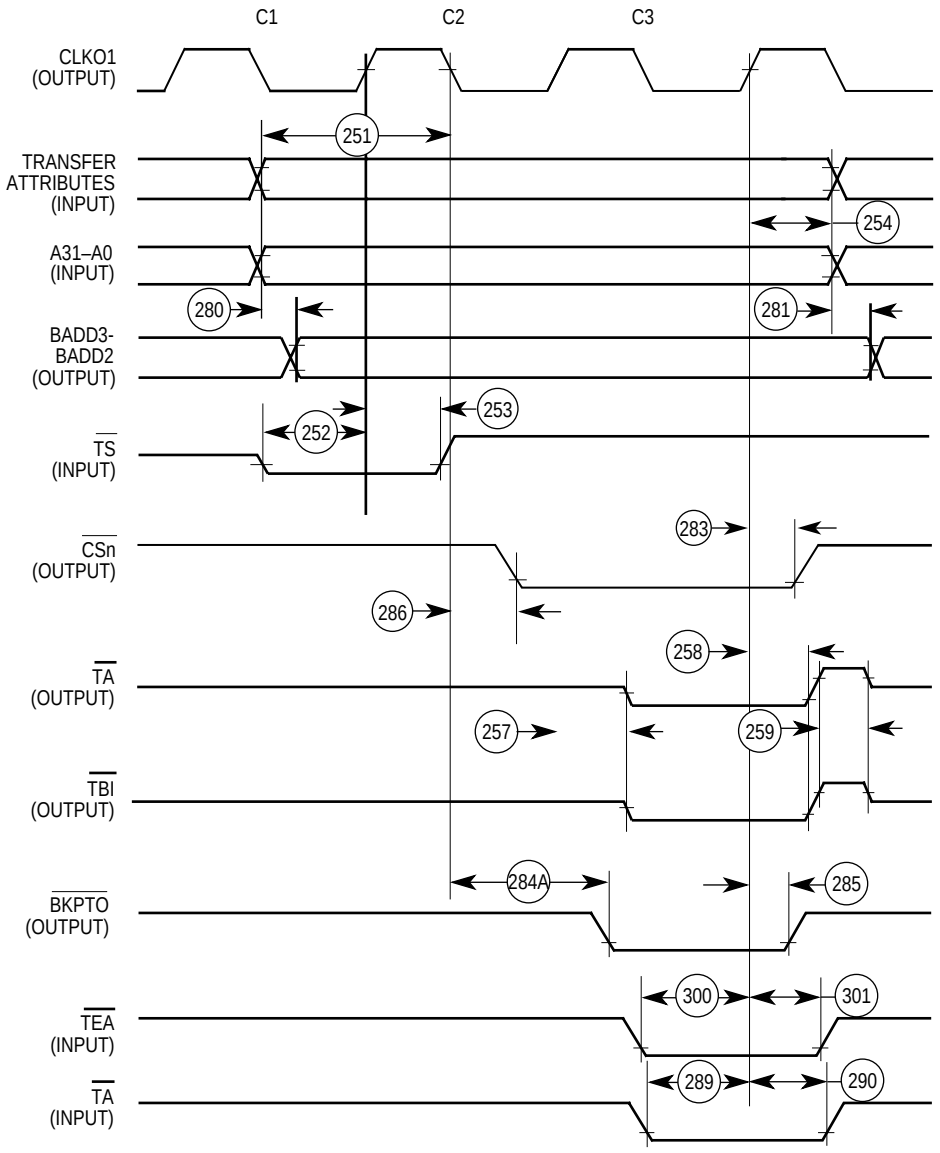
Figure 10-45(b) MC68040/EC040 SRAM Read Cycle (TSS40=1, CSNT40=1)

$\overline{OE}$ and $\overline{WE}$ signals are not supported when TSS40 is set to 1.

The following figure should be added below figure 10-45(a)
